**Flood Control Project Maintenance
Levee Inspections**

Maintenance Issue Types Only, Levee Inspection Report By Mile - Fall 2019

Reclamation District No. 2085 Kasson

Waterway	Bank	Unit Miles	Inspection Start/End	Inspector
Unit No. 01 San Joaquin River	Left	5.29	10/09/2019 10/09/2019	Alberto De Leon

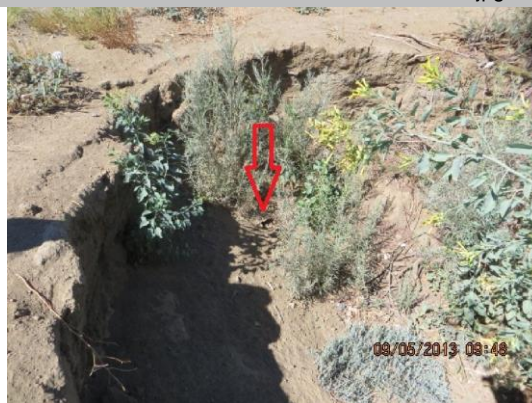
Photo 1 of 3 : UCIP_FA_2019_52493_62262.jpg

Comment Code					
Inspector Comment					
DS_ID:20677 FS_ID:52493 EP_NO: N/A Repair Type: No Action Needed Crossing Status: Found UCIP Comments: Pipe has been removed by LMA.Previous:Pipe abandoned. Erosion around pipe on WS slope. Pipe severely corroded. Pier badly damaged. FIELD_STRUCT_DESC: *REMOVED* 14-inch steel drainage pipe through the levee, 4.5 feet below the crown. Pump on pile structure in ditch on the landside (LS). Siphon breaker in corrugated metal pipe (CMP) riser on the waterside (WS) shoulder. Pipe removed by LMA. (Permit Application No. T2013179, 2014 - Surinder Sandhu, submitted to CVFPB. Permit was not needed per CVFPB review). [Additional Reference(s): DWR Levee Log, 2005. USACE San Joaquin O&M Manual 11, 1968, (HLM 0.47)]. FS Date: 9/5/2013

(Pipe removed by LMA)Pipe on WS with erosion into levee slope.

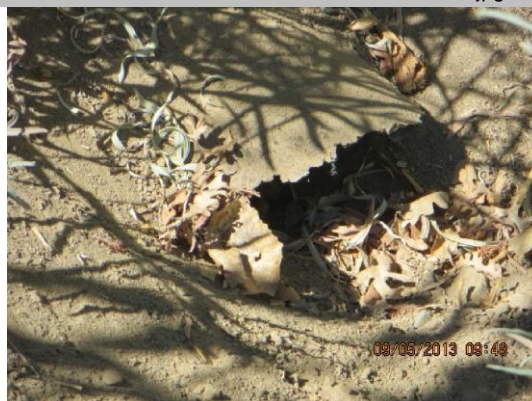
Photo 2 of 3 : UCIP_FA_2019_52493_62261.jpg

Pipe removed from WS toe.

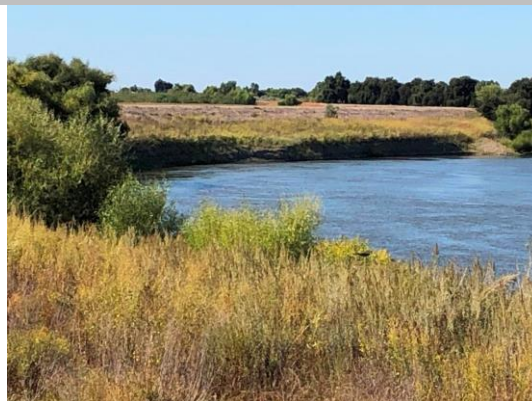
Photo 1 of 3 : SJR2019_RD2085U01RM62.43_1.JPG

LM Start	1.15	Rating **	M	Issue No.	1
LM End	1.26	Issue Type +	Ma	Location *	
Category	Supplemental			GPS Latitude/Longitude	
				Start	End
Item	DWR Erosion Survey			37.715996 °	37.715996 °
				-121.291229 °	-121.291229 °
DWR ID	RD2085U01RM62.43				
Comment Code					
Inspector Comment					
Site ID: RD2085U01RM62.43 09/17/2019: No significant change has been observed at the site. The site is covered with dense and tall vegetation. 11/02/2017: The erosion was reported to DWR by LMA. The site is located at the outside of a slight river bend. Both levee slope and river bank are covered with dense vegetation.

Looking downstream at the erosion site.

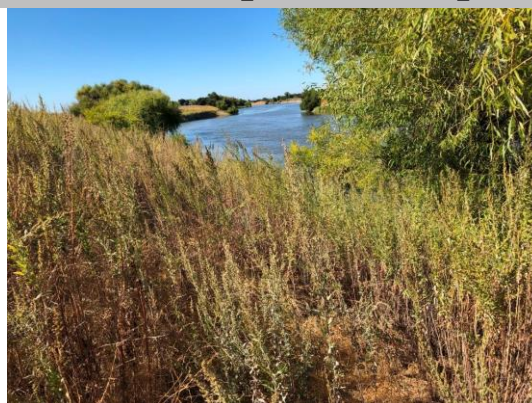
Photo 2 of 3 : SJR2019_RD2085U01RM62.43_2.JPG

Looking downstream at the erosion site. Note the dense vegetation and the trees at the upstream of the erosion.

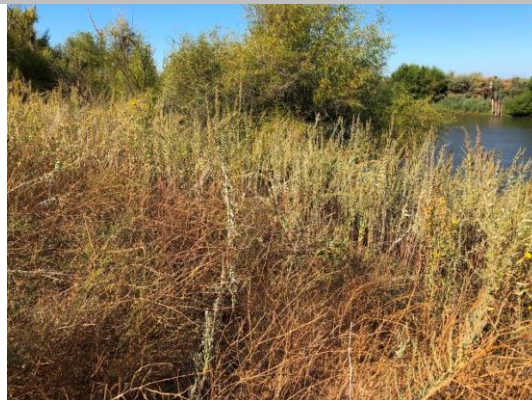
Photo 3 of 3 : SJR2019_RD2085U01RM62.43_4.JPG

Close-up view of the erosion.

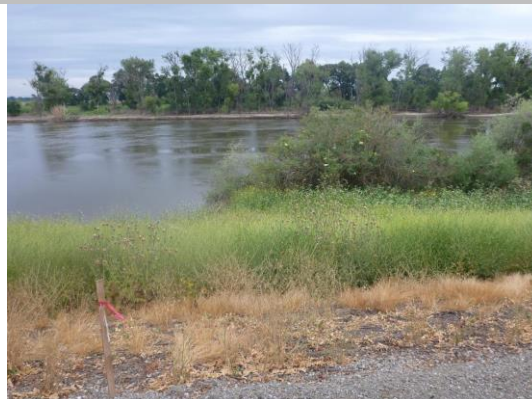
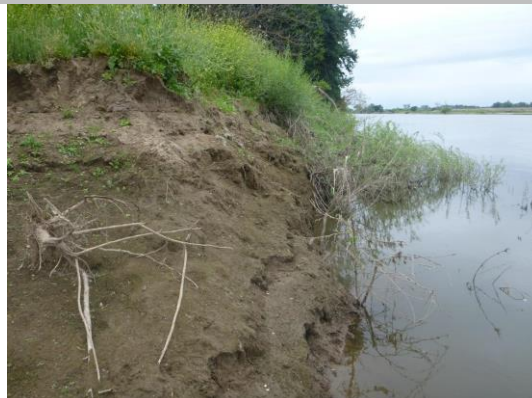
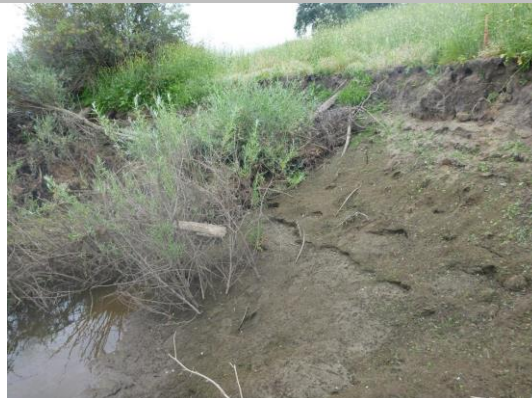
Levee Evaluation Comments
 Description:
 Site ID No:105
 Site Designation:FSRP-13-55
 Repair Type: Erosion
 Rating:Serious
 Field Date:6/8/2017
 Notes: This site is repaired as of this inspection date. Fall 2018.

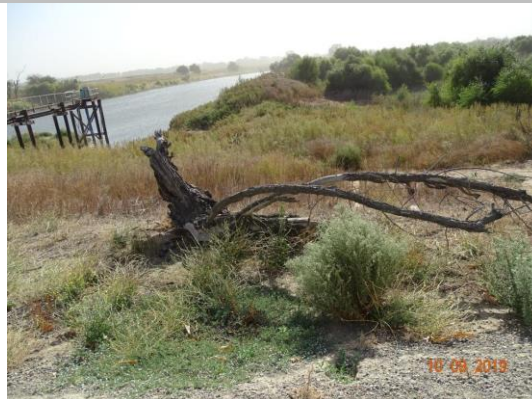
Photo 1 of 1 : FA_2019_RD2085_113_47_20191111_00059.jpg

LM Start	2.83	Rating **	M	Issue No.	47
LM End	2.83	Issue Type +	Ma	Location *	WS
Category	Earthen Levee			GPS Latitude/Longitude	
				Start	End
Item	Encroachments			37.699545 °	37.699545 °
				-121.276389 °	-121.276389 °
DWR ID	DWR_RD2085_01_f_2019_47				
Comment Code					
TR : Tree or limb					
Inspector Comment					
There are tree limbs from a dead tree on waterside slope. Fall 2019

View of tree limbs on waterside slope. Fall 2019

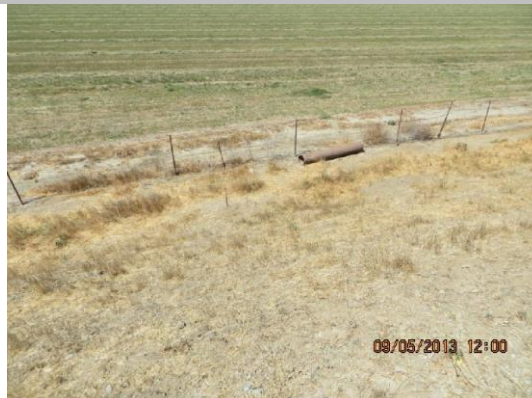
Photo 1 of 3 : UCIP_FA_2019_19433_32990.jpg

LM Start	3.30	Rating **	M	Issue No.	65	
LM End	3.30	Issue Type +	Ma	Location *		
Category	Supplemental			GPS Latitude/Longitude		
				Start		End
Item	DRAFT DWR UCIP LMA Responsibility			37.693618 °		37.693618 °
				-121.277639 °		-121.277639 °
DWR ID	20693					
Comment Code						
Inspector Comment						
DS_ID:20693						
FS_ID:19433						
EP_NO: N/A						
Repair Type: Non-Urgent						
Crossing Status: Found						
UCIP Comments: Pipe appears abandoned and should be done so properly.						
FIELD_STRUCT_DESC: *ABANDONED* 10-inch steel storm drainage pipe through the levee, 4 feet below the crown. T-post marks location of pipe at the landside (LS) toe. Steel plate welded over pipe on the waterside (WS) slope. [Additional Reference(s): USACE San Joaquin O&M Manual 11, 1968, (HLM 3.34), As-Built Drawings available, DWG 7-4-1685].						
FS Date: 9/5/2013

T-post marking pipe end on LS toe. 10-inch pipe debris on LS toe.

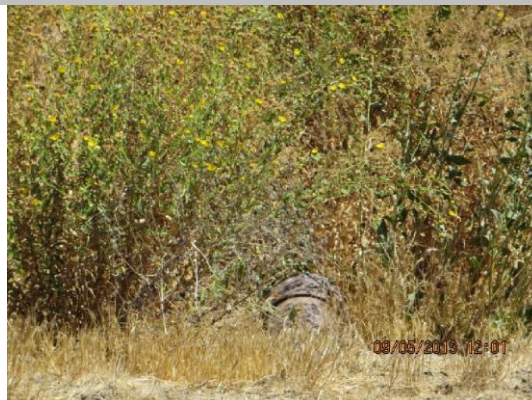
Photo 2 of 3 : UCIP_FA_2019_19433_32989.jpg

Pipe visible on WS slope.

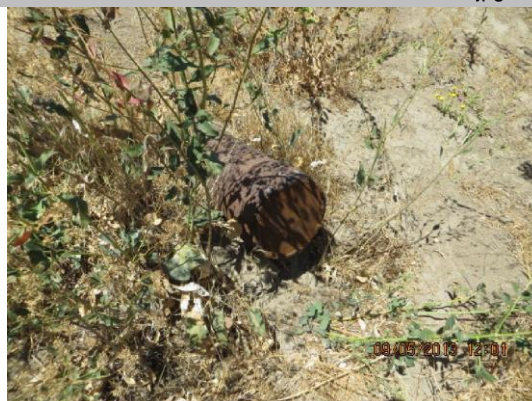
Photo 3 of 3 : UCIP_FA_2019_19433_32988.jpg

Pipe visible on WS slope. Steel plate welded over end.

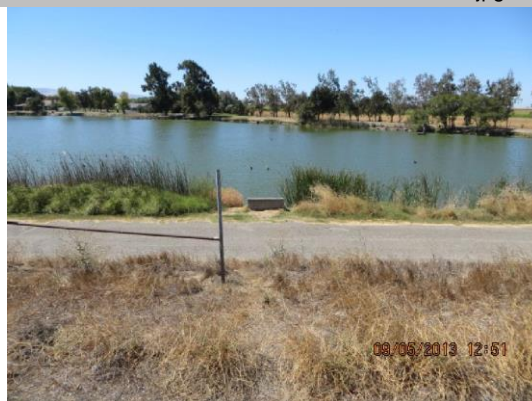
Photo 2 of 3 : UCIP_FA_2019_19436_32996.jpg

Concrete headwall off LS toe.

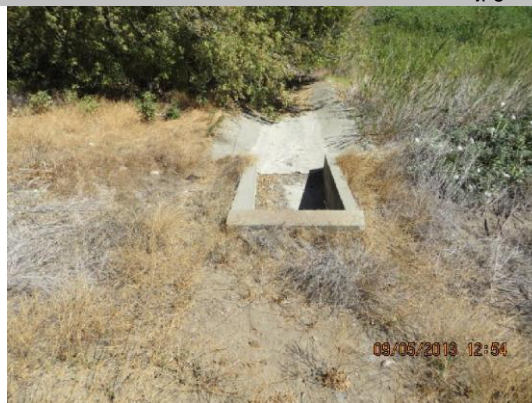
Photo 3 of 3 : UCIP_FA_2019_19436_32995.jpg

Concrete U-shaped headwall on WS slope.

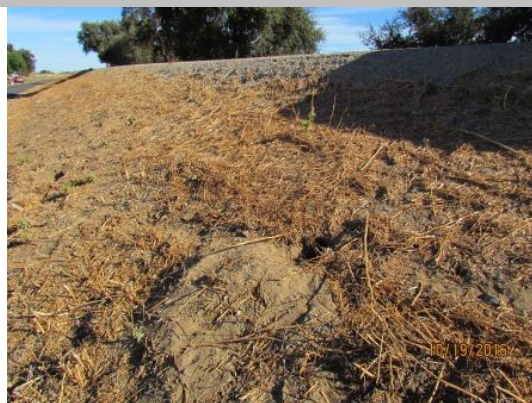
Photo 1 of 1 : FA_2019_RD2085_113_36_20190830_00019.jpg

LM Start	3.86	Rating **	M	Issue No.	36
LM End	4.02	Issue Type +	Ma	Location *	LS
Category	Earthen Levee			GPS Latitude/Longitude	
				Start	End
Item	Animal Control			37.686059 °	37.683882 °
				-121.276745 °	-121.275923 °
DWR ID	DWR_RD2085_01_f_2016_36				
Comment Code					
A3 : No rodents visible, but rodent burrows visible; need to backfill and compact or grout burrows.					
Inspector Comment

View of the rodent holes on the levee slope.

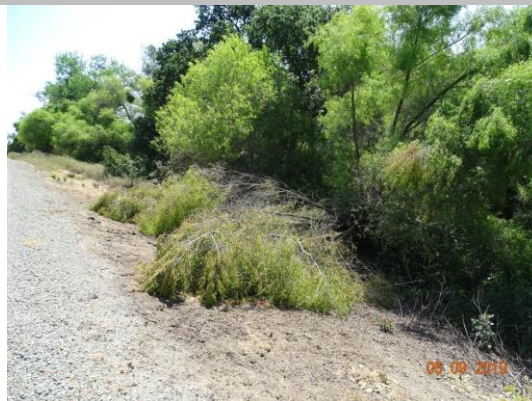
Photo 1 of 1 : FA_2019_RD2085_113_44_20190830_00021.jpg

LM Start	4.98	Rating **	U	Issue No.	44
LM End	4.98	Issue Type +	Ma	Location *	WS
Category	Earthen Levee			GPS Latitude/Longitude	
				Start	End
Item	Encroachments			37.677972 °	37.677972 °
				-121.268077 °	-121.268077 °
DWR ID	DWR_RD2085_01_s_2019_44				
Comment Code					
TR : Tree or limb					
Inspector Comment					
There are tree limb/branches broken on the waterside slope.

Broken tree limb on waterside slope. (Spring 2019)

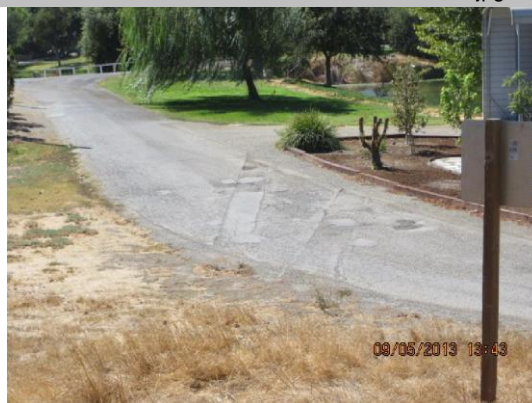
Photo 1 of 3 : UCIP_FA_2019_23060_39184.jpg

LM Start	5.22	Rating **	A/W	Issue No.	69
LM End	5.22	Issue Type +	Ma	Location *	
Category	Supplemental			GPS Latitude/Longitude	
				Start	End
Item	DRAFT DWR UCIP LMA Responsibility			37.675271 °	37.675271 °
				-121.269281 °	-121.269281 °
DWR ID	20686				
Comment Code					
Inspector Comment					
DS_ID:20686					
FS_ID:23060					
EP_NO: N/A					
Repair Type: No Action Needed					
Crossing Status: Found					
UCIP Comments:					
FIELD_STRUCT_DESC: 30-inch reinforced concrete drainage pipe through the levee, 10 feet below the crown. Concrete U-shaped headwall on the waterside (WS) end. Two corrugated metal cutoff walls. Flap gate on the WS end. [Additional Reference(s): DWR Levee Log, 2005. USACE San Joaquin O&M Manual 11, 1968, (HLM 5.12)].					
FS Date: 9/5/2013

Cuts in pavement off LS toe good indicator of pipe location.

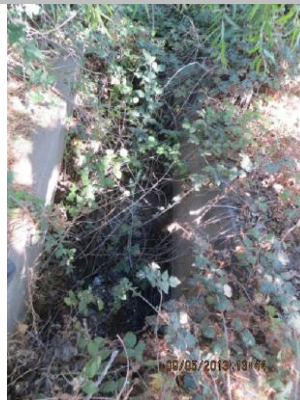
Photo 2 of 3 : UCIP_FA_2019_23060_39183.jpg

Concrete U-shaped headwall visible on WS toe.

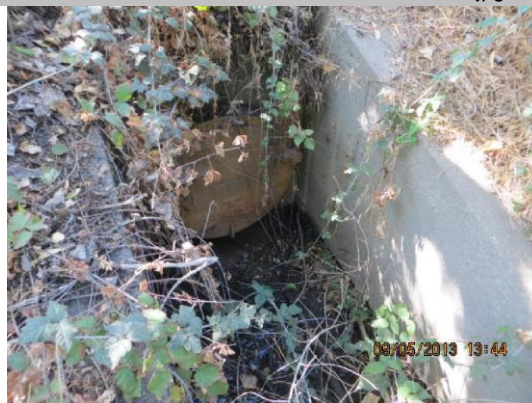
Photo 3 of 3 : UCIP_FA_2019_23060_39182.jpg

Concrete U-shaped headwall and flapgate visible on WS toe.

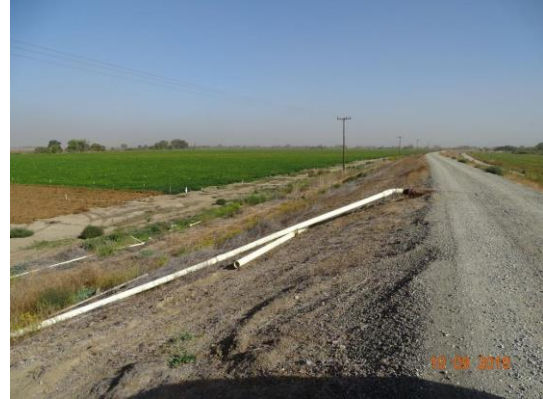
Photo 1 of 1 : FA_2019_RD2085_114_3_20191111_00001.jpg

LM Start	0.05	Rating **	A	Issue No.	3
LM End	0.23	Issue Type +	Ma	Location *	LS
Category	Earthen Levee			GPS Latitude/Longitude	
				Start	End
Item	Vegetation			37.705430 °	37.707842 °
				-121.274340 °	-121.272924 °
DWR ID	DWR_RD2085_02_f_2019_3				
Comment Code					
V2 : Remove the wild growth other than native grasses from the levee slopes.					
Inspector Comment					
Annual vegetation is well maintained.

View of vegetation on landside slope. Fall 2019

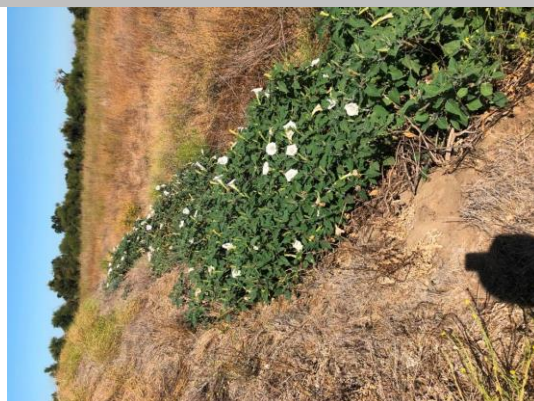
Photo 2 of 3 : SJR2019_DWR_RD2085_03_s _ 2014_1_3.JPG

LM Start	0.21	Rating **	M	Issue No.	1 (cont)	
LM End	0.21	Issue Type +	Ma	Location *		
Category	Supplemental			GPS Latitude/Longitude		
				Start	End	
Item	DWR Erosion Survey			37.682798°	37.682798°	
				-121.262059°	-121.262059°	
DWR ID	RD2085U03RM69.27					
Comment Code						
Inspector Comment						
Site ID: RD2085U03RM69.27						
09/17/2019: Erosion is covered by vegetation.

Close view of the erosion.

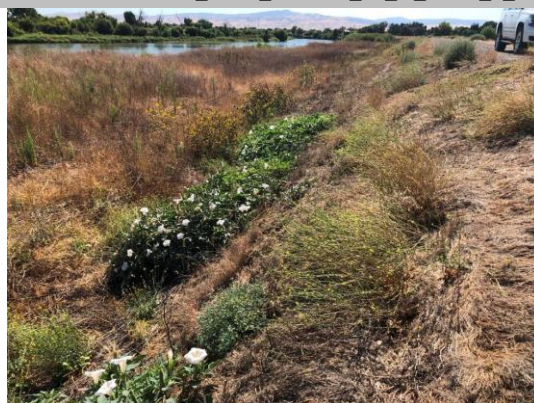
Photo 3 of 3 : SJR2019_DWR_RD2085_03_s _ 2014_1_5.JPG

Look upstream of the erosion.
